Estimating the TNT equivalence of a 15-ton single base powder explosion through damaged building profiles analyses

Back in 1964 President Vargas Works was the only place in the country which processed single base powder for the Brazilian Armed Forces. Then its industrial activity was quite strong and around 4:45 a.m. of 23rd September an intense decomposition of nearly 15 ton of that material took place in one of the production lines workshops. The consequences of this explosion were the destruction and extensive damage to the workshops around its epicenter. At that time pictures of all affected buildings were taken and their damages fully described. This led to the present work which consists in the evaluation of the TNT equivalent charge of the explosion using the concept of damage category developed by UK engineers based on the WWII damaging bombing data.

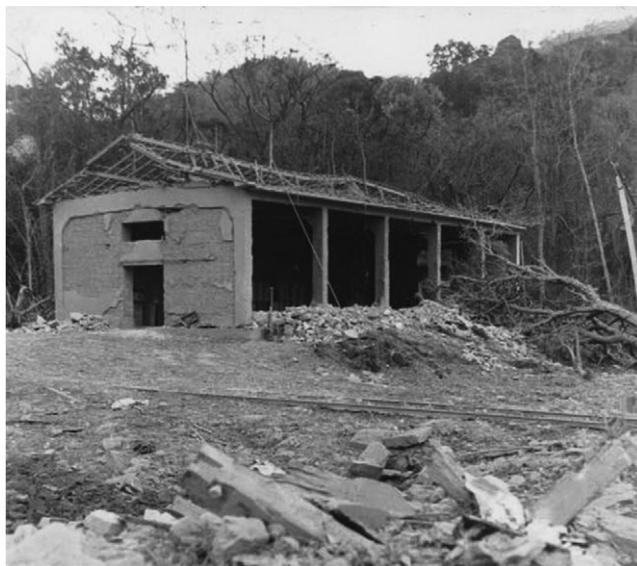
Fig. 1. Single base powder boxes storage depot. Picture taken 50 m from epicenter.

- (a) *Complete demolition*: At least one wall has crashed as shown in Figs. 1–4.
- (b) *Partial demolition*: At least one wall shows severe cracks and crashing is imminent of follow as displayed in Fig. 5.

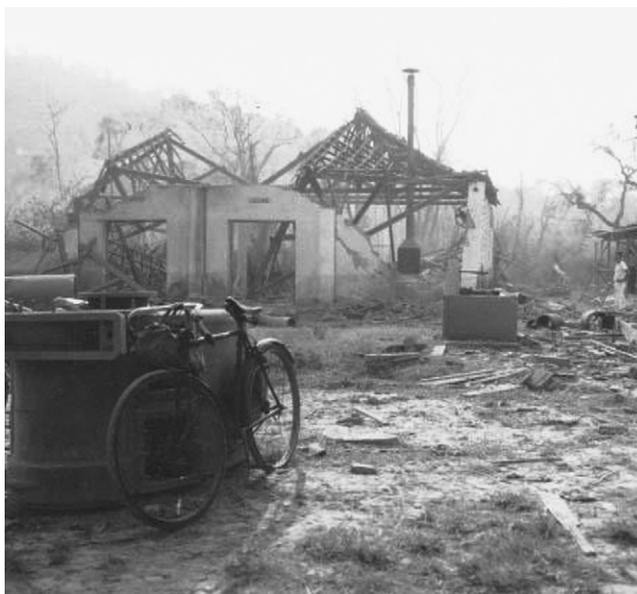
Fig. 2. Machine shop I. Picture taken 80 m from epicenter (obviously the bicycle belonged to the photographer).

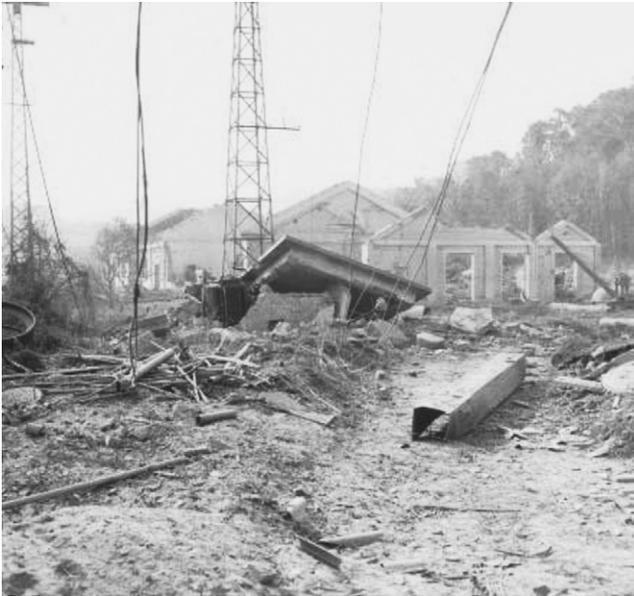
Fig. 3. Electric power room. Picture taken 80 m from epicenter.

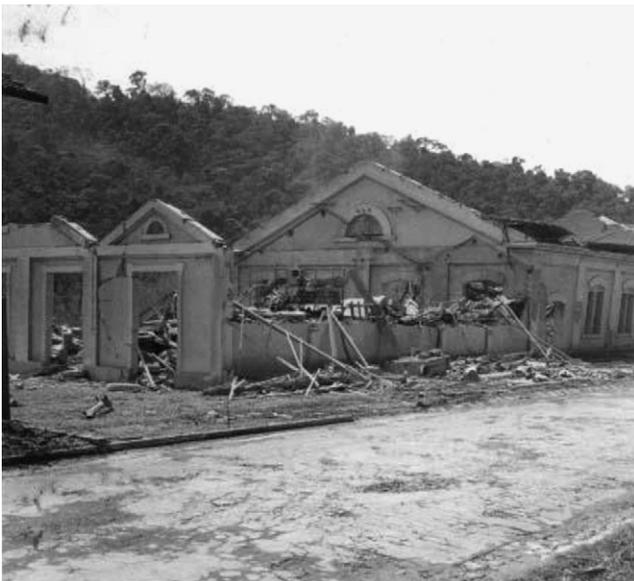
Fig. 4. Carpentry. Picture taken 110 m from epicenter.

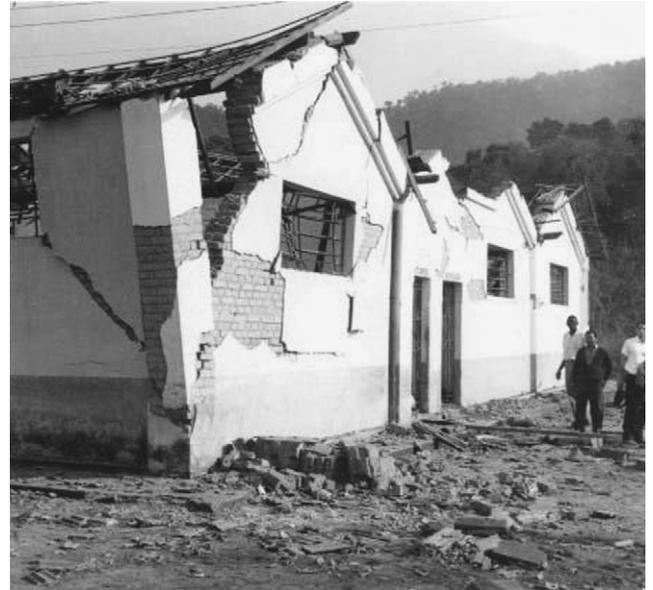
Fig. 5. Machine shop II. Picture taken 140 m from epicenter.

- (a) Total collapse (as shown in Figs. 5–7).
- (b) Partial collapse (as shown in Fig. 9).
- (c) *Tiles (ceramic) pulled out*: The roof structure remains but more than 70% of tiles are pulled out, as it can be seen in Fig. 10.
- (d) *Tiles (ceramic) displaced*: Less than 50% of tiles were pulled out, as shown in Fig. 12.
- (e) *Tiles (ceramic) with cracks*: Small pieces of tile were found inside the building, unfortunately there is no picture available.

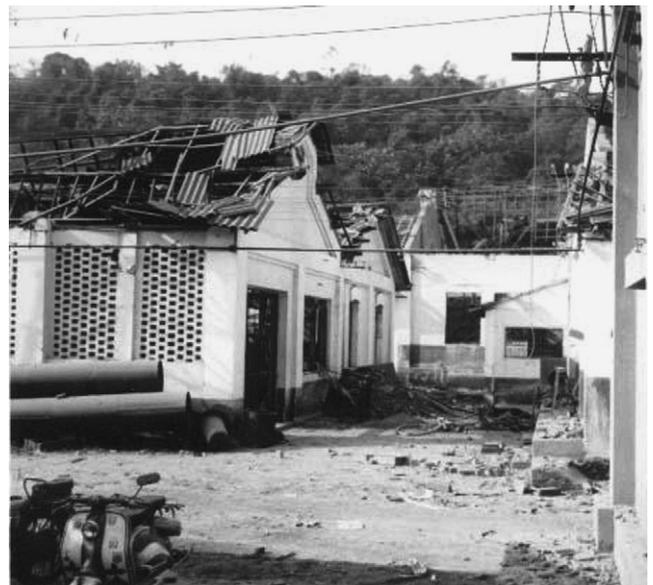
Fig. 6. Machine shop III. Picture taken 170 m from epicenter.

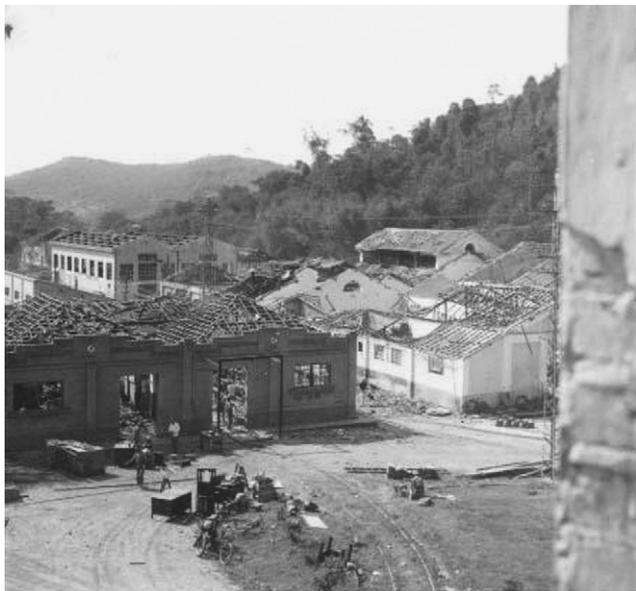
Fig. 7. General view of machine shops Yard. Picture taken 180 m from epicenter.

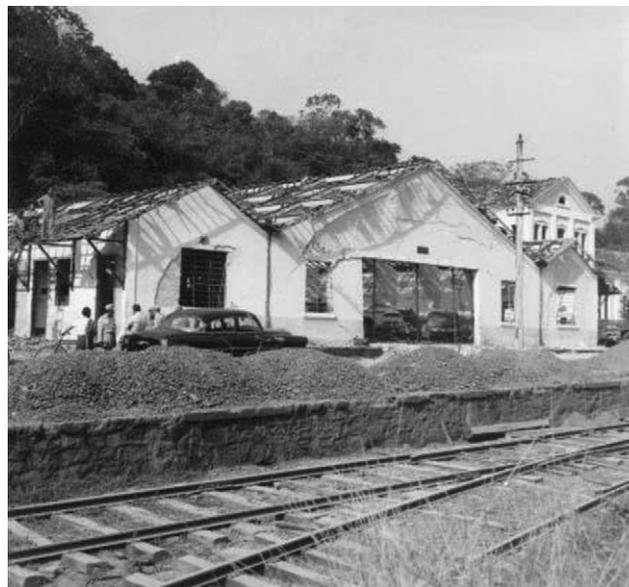
Fig. 8. Trucks repair shop. Picture taken 180 m from epicenter.

(c) *Gaping cracks*: At least one wall shows cracks not too severe to need demolition as shown in Figs. 8 and 9.

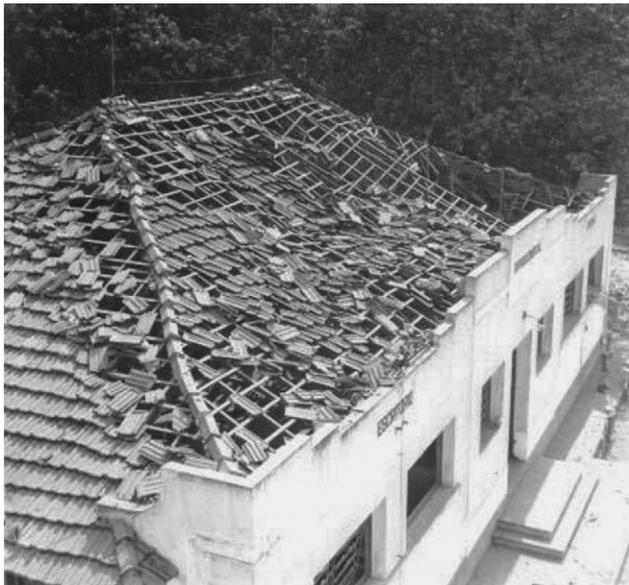
Fig. 9. Sales department building. Picture taken 190 m from epicenter.

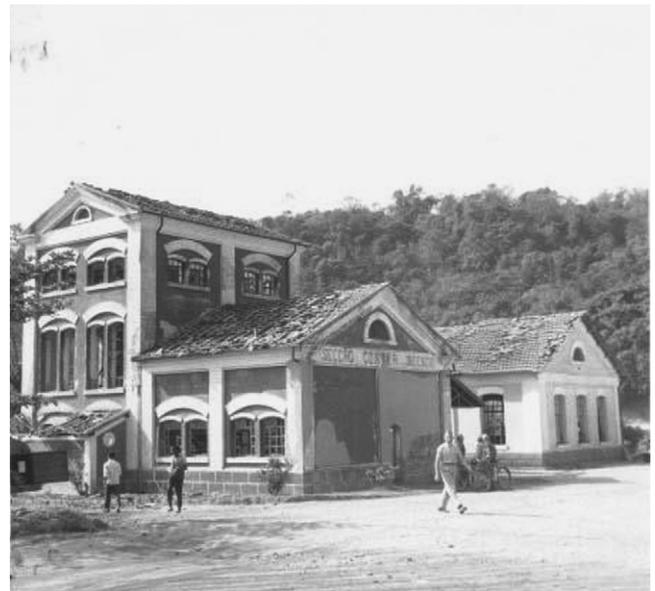
Fig. 10. Fire department building. Picture taken 240 m from epicenter.

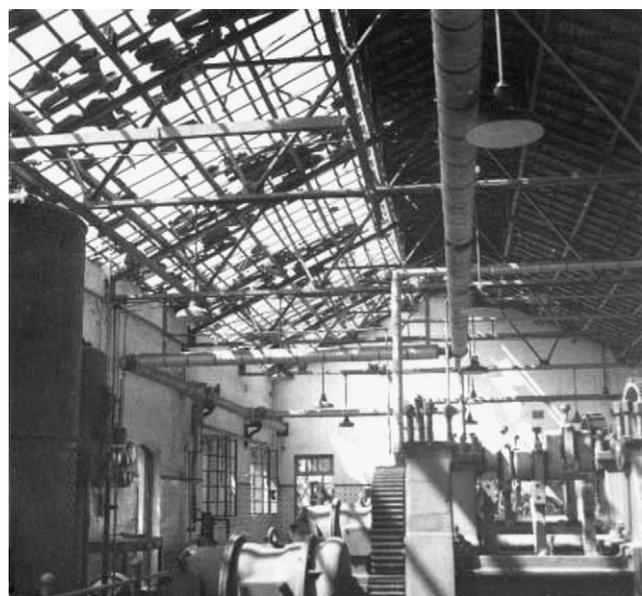
Fig. 12. Boiler room. Picture taken 340 m from epicenter.
