Assessment of the Impacts of the 2023 Earthquake in Diyarbakir, Turkey with CBERS-4A Satellite Images

Bruno G. Miranda¹, Felipe de O. Passos¹, Gabriel Dietzsch¹,
Ocione D. N. Filho¹, Tiffany L. J. T. de Mendonça¹, Thales S. Korting¹,
Laércio Massaru Namikawa¹, Douglas F. M. Gherardi¹, Luciano P. Pezzi¹, Gilberto R.
Queiroz¹

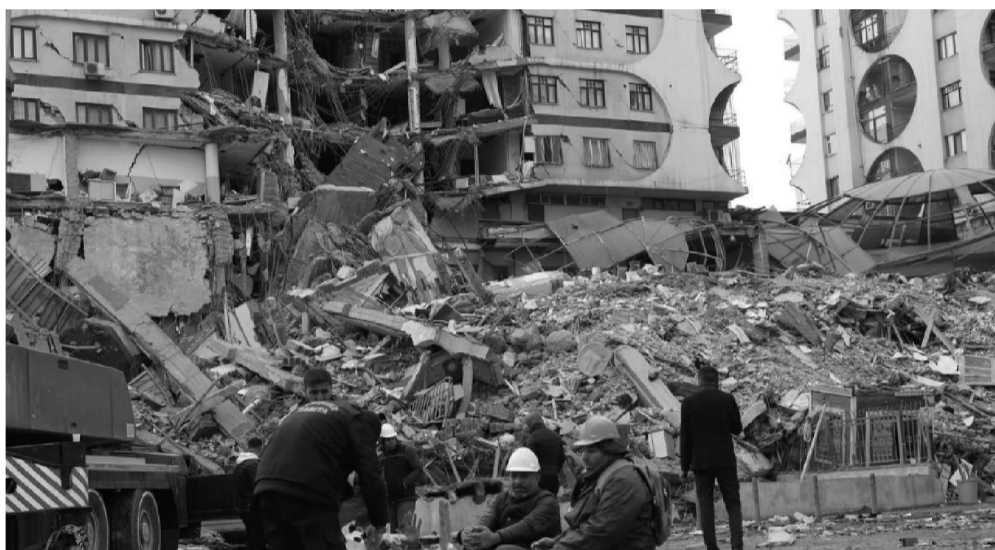
Figura 1. Earthquake damage in the city of Diyarbakir, Turkey in February 2023.

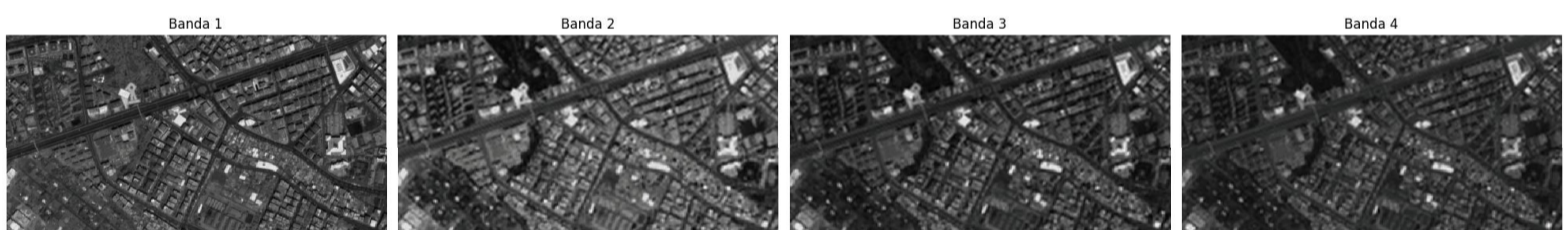
Figura 4. Brightness and contrast differences between bands 1 and 4 of the CBERS-4A satellite for the 2021 image (before the earthquake). Possibilita

After visual analysis, it was possible to detect that Band 1 proved to be the sharpest. This band corresponds to the visible blue spectrum, imaging wavelengths in the 0.45 to 0.52 μm range, with a resolution of 8 meters.

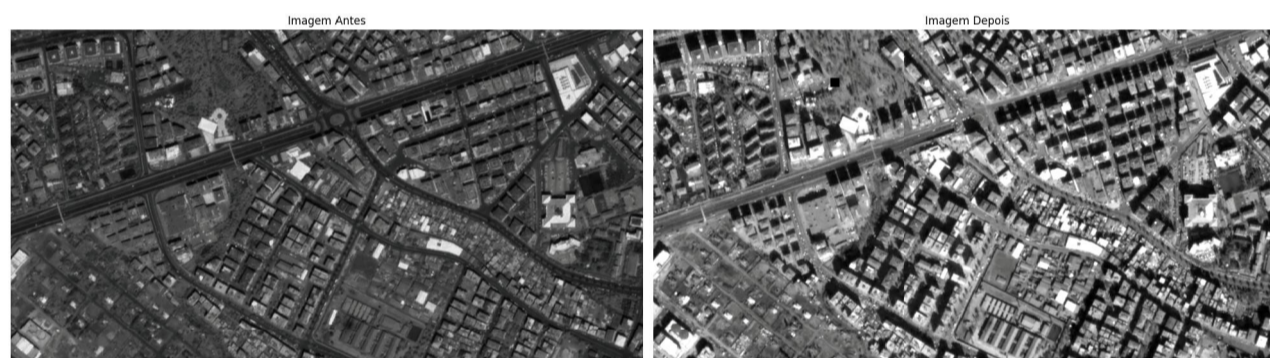
Figure 6. Before and After Images - Contrast. Representation of contrast in pre- and post-earthquake images.

Looking at the images resulting from the normalization of the grey levels, it was necessary to improve the contrast of the 2021 image, using a gain factor of 1.5. The result of the image with improved contrast (2021) and that of 2023, together with the final histogram, are shown in Figures 6 and 7, respectively.

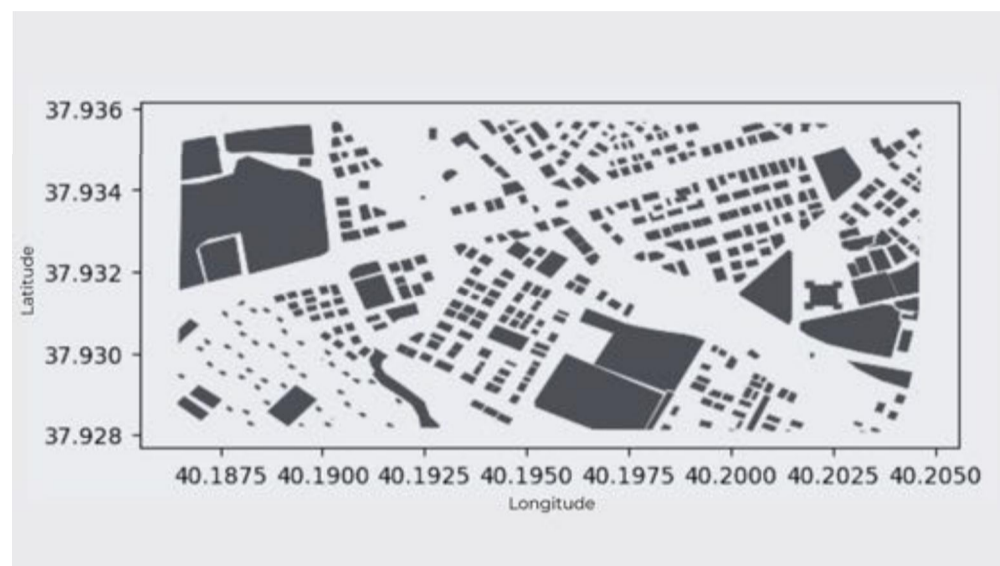
Figura 8. Shapfile Layer Buildings Open Street Maps for the Study region, the polygons indicate areas identified as buildings.

The *buildings* layer of the *Open Street Maps* was used to detect changes caused by the disaster. This layer was obtained via QGIS and its *shapefile* is inserted into Figure 8, in which it shows the polygons identified as buildings (black shapes) in the study area.

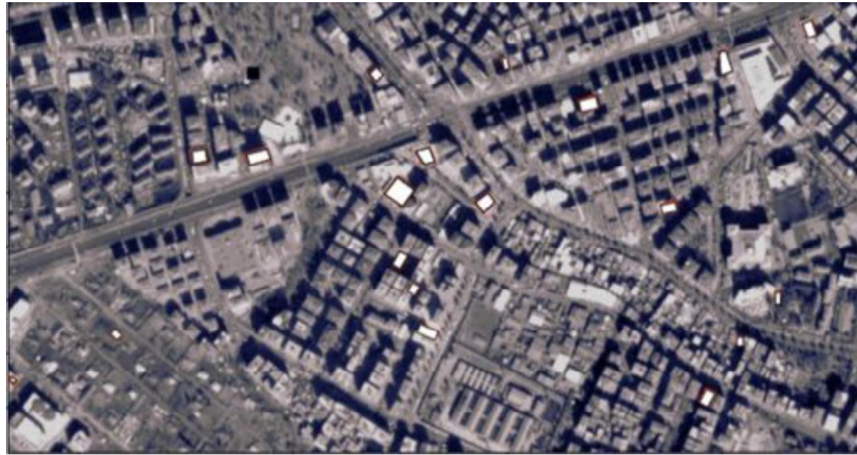
Figura 10. Shapefile Layer Buildings - Detected Changes. The polygons highlighted in the image represent the buildings that were identified as detected changes after the earthquake.

Based on the 3 measurements made (mean, entropy, and standard deviation), a procedure was carried out to detect the *shapefiles* with changes in common for all the statistics. The mean indicated changes in 20 polygons, the standard deviation 45, and the entropy indicated 368 values, resulting in 19 polygons in common. Therefore, the polygons that showed differences were selected and plotted in a new resulting shapefile so that visual identification could be done with the satellite images of the affected areas, which are shown in Figure 9. Finally, the *shapefile* generated in Figure 9 is overlaid with the post-earthquake image (2023) so that the areas affected by the earthquake disaster in Turkey can be mapped (Figure 10).
